Contract #: 04-0120F4Cty: SF/ALA Rte: 80 PM: 13.2/13.9File #: 1.28**WELDING INSPECTION REPORT****Resident Engineer:** Siegenthaler, Peter**Address:** 333 Burma Road**City:** Oakland, CA 94607**Report No:** WIR-018430**Date Inspected:** 01-Dec-2010**Project Name:** SAS Superstructure**OSM Arrival Time:** 1000**Prime Contractor:** American Bridge/Fluor Enterprises, a JV**OSM Departure Time:** 1830**Contractor:** American Bridge/Fluor Enterprises, a JV**Location:** Job Site

WELDING INSPECTION REPORT

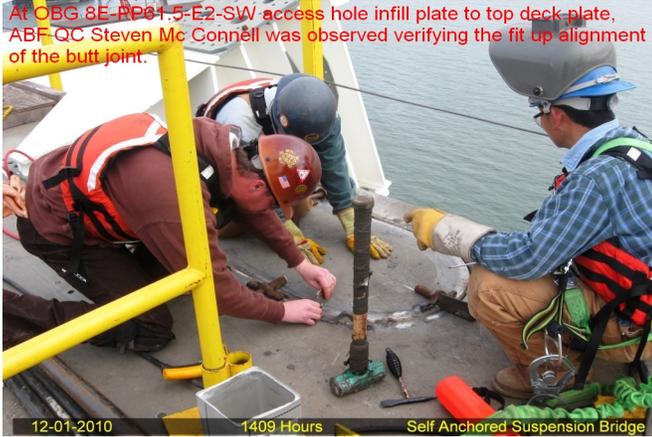
At OBG 8E-PP01-5-E2-SW access hole infill plate to top deck-plate, ABF QC Steven Mc Connell was observed verifying the fit up alignment of the butt joint.
